HYDRO-TRIAD, LTD

NATIONAL WESTERN STOCK SHOW
ENVIRONMENTAL ASSESSMENT REVIEW

PHASE II

March, 1991

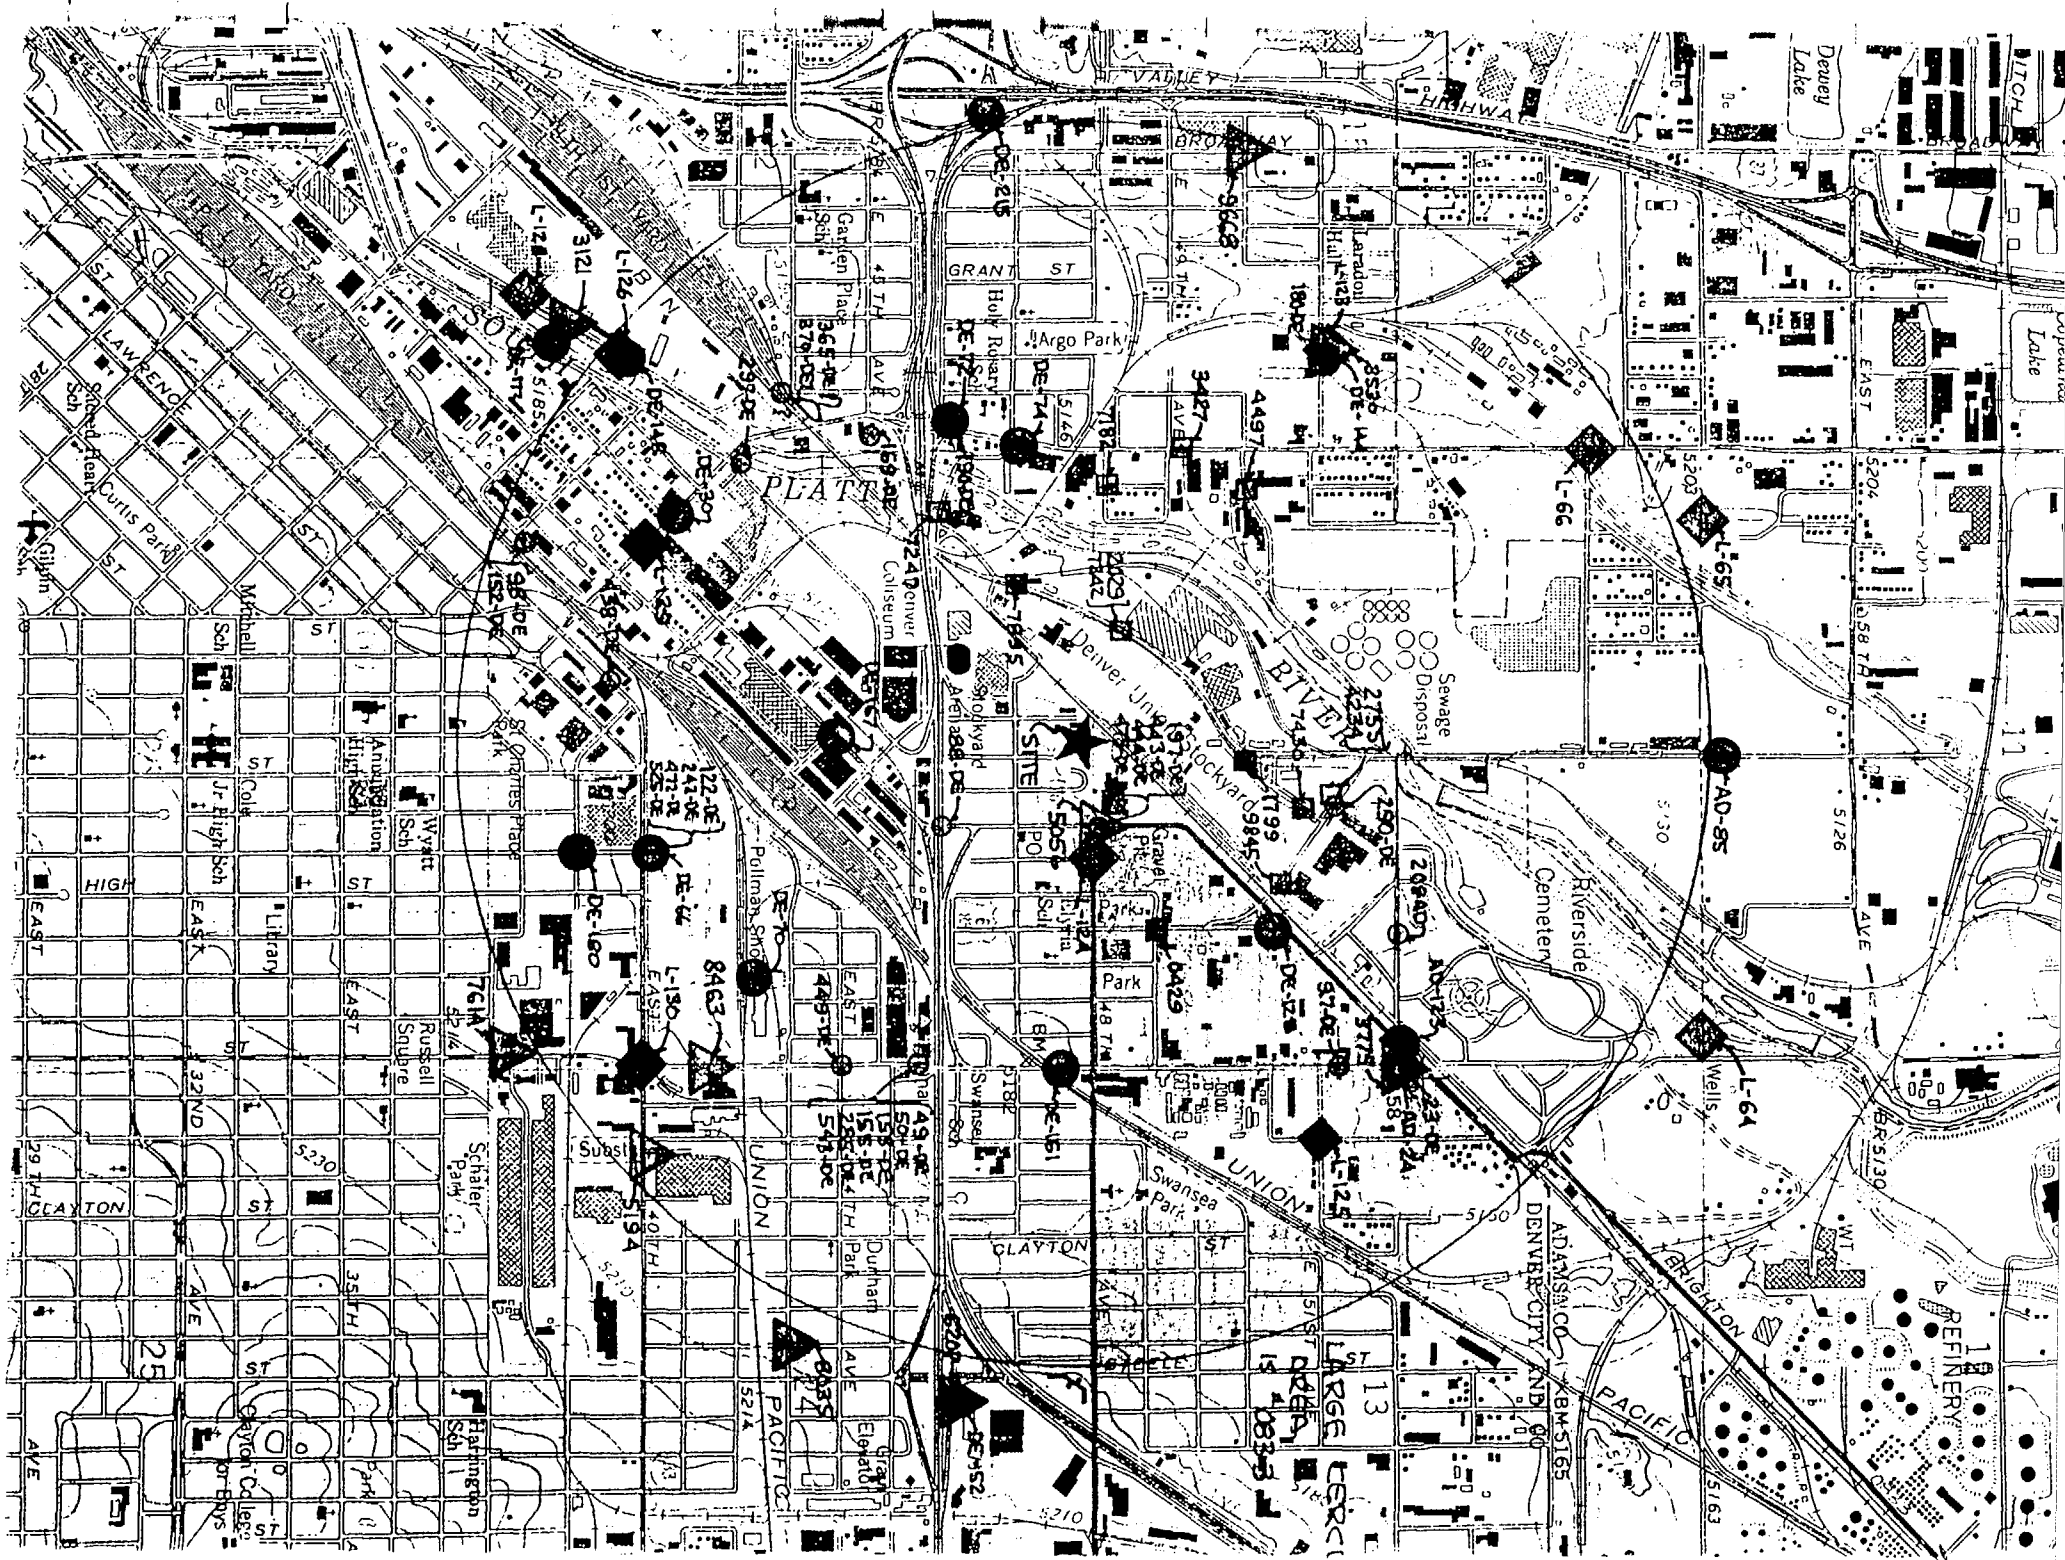
The locations for these occurrences is shown on Figure 3. The reports are included as Attachment E. The RCRA Generator/TSD Facilities were only plotted within 0.5 miles because there were so many of them. There were 13 facilities located within the 0.5 mile range.

The occurrences of significance are those within a close proximity to the site, especially the ones to the southeast. The southeast area should be considered upgradient because the direction of ground water flow is probably to the northwest, towards the Platte River. This assumption is substantiated by Industrial Compliance, Inc which is conducting an environmental assessment of an underground storage tank leak in an area southwest of Phase 2.

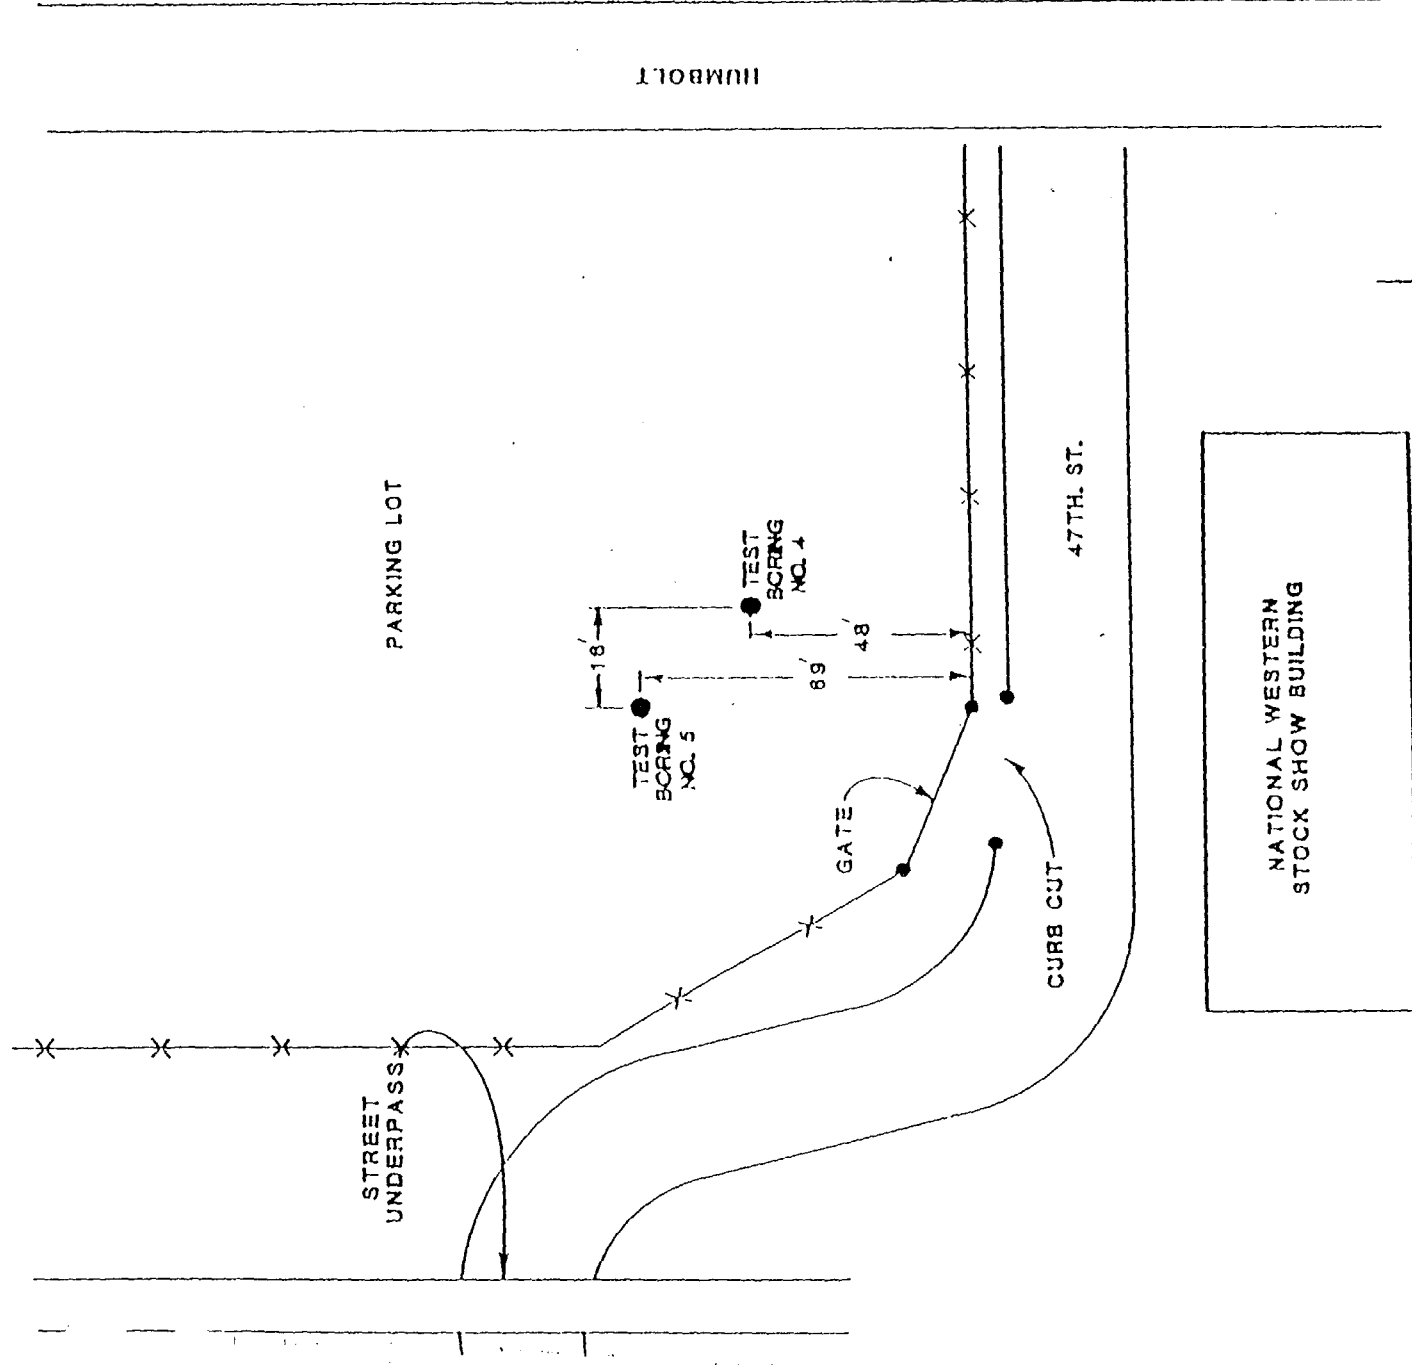
SITE PLAN
FIGURE 1

Yockey Trucking had underground fuel storage tanks which were removed in July, 1990. The location of the tanks are identified on the two Figure 1 overlays. On July 19, 1990 A.G. Wassenaar conducted a drilling and sampling program in the location where the tanks were removed. The soil samples were analyzed with total recoverable petroleum hydrocarbons reported at 26.7 and 64.3 parts per million (ppm). Since this level was below the Colorado Department of Health 100 ppm action level, the A.G. Wassenaar recommendation was that "no further action be taken at this site with regard to soil testing." A copy of the Wassenaar report is included as Attachment C.

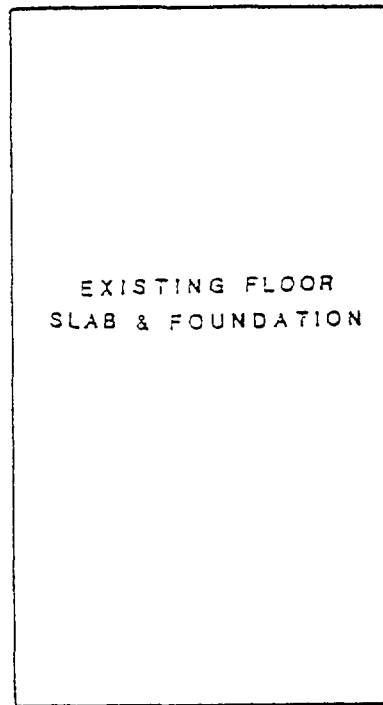
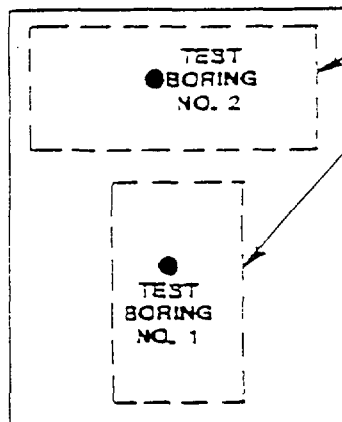
The tanks were removed on December 7, 1988 by Wayne Gomez Demolition and Excavating, Inc. The removal was monitored and documented by C.R. Adams Company. A copy of the report was provided by Gomez and is included as Attachment D. Two soil samples were collected beneath the center-line of the excavated tanks and submitted to an independent laboratory for total petroleum hydrocarbon analysis. The results were reported as "not detected." The author of the report said "We do not believe the level of petroleum contamination indicated by these tests represents an environmental hazard." He went on to say that "We do not believe additional clean-up action or disposal of excavated soils is required at the site."

REPORTED TANK LOCATION

EXCAVATION LIMITS
